Manhole Inspection Summary

Manhole # S01UU1018MH

Insp Date: **8/11/06 8:40 AM**

Location Address: **6103 Gist Ave**

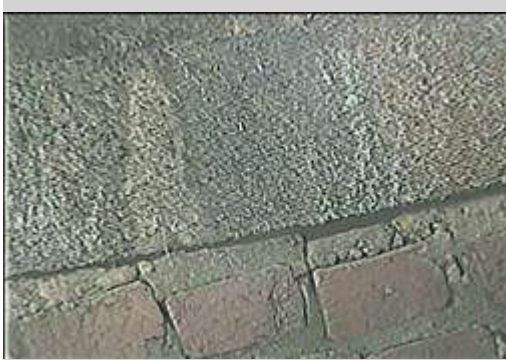
Defect

☒ **Leaks**

leakage through lid

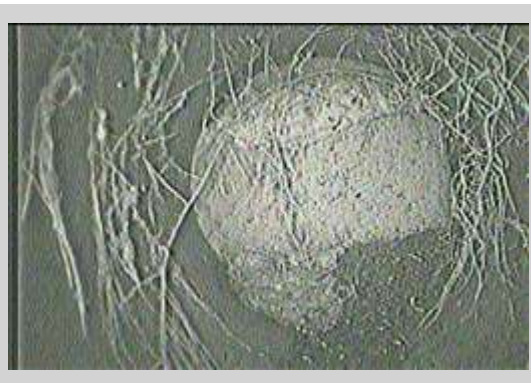
Pipe In @ 6 O'Clock

Infiltration: **None** Pipe Seal Cond: **Roots**
